# Restoration and strengthening measures after a large-volume cave-in occurred during Road 16 construction, Jerusalem, Israel

**ABSTRACT:** A large-volume cave-in occurred in highway tunnel TU4, already fully excavated. The excavation of the collapsed section had been completed 7 months before in TU4 and 5 months in the adjacent TU3. Before the collapse, there had been no signs of possible ongoing criticality or instability; after their sudden first hint, in few minutes, the collapse developed with a 50 m high chimney up to the surface, forming a crater, of about 1800 m<sup>3</sup>, while the material accumulated in the tunnel had a volume of about 2600 m<sup>3</sup> in bench. The performed preliminary investigations are reported, carried out to clarify the geological-geotechnical context and the possible causes of the collapse and to establish the best measures to be implemented to restore the tunnels. Hence, the design and the measures applied to re-excavate the TU4, to secure both tunnels and to prevent the occurrence of further collapses will be illustrated.

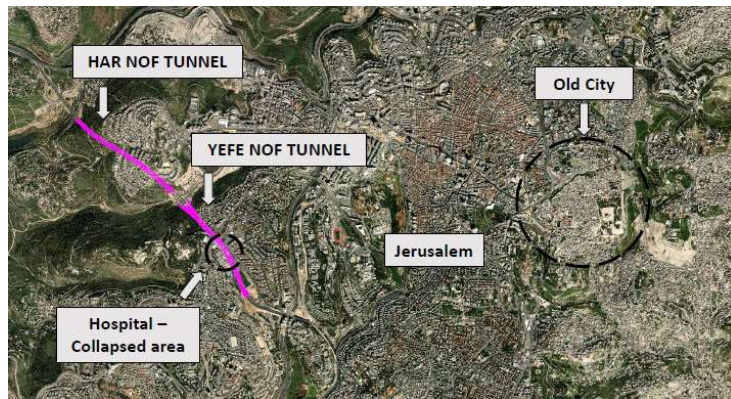
Figure 1. Road 16's plan (property of the authors).

The Road 16 highway represents the new road axis of penetration into Jerusalem city center for those coming from Tel Aviv (Brunori, Moja, Pace, Paonessa, Pizzarotti 2021). As shown in Figure 1, the project involved the construction of two double-tube tunnels, Har Nof (TU1 and TU2 – L = 1400 m) and Yefe Nof (TU3 and TU4 – L = 1250 m), as well as two underground entry ramps in the Yefe Nof tunnel (TU11 and TU12). The construction required sequential excavation in rock of sections with variable excavation width, from a minimum of 12.5 m to a maximum of 25.0 m, with overburden varying from 140 m to few meters at the adits.

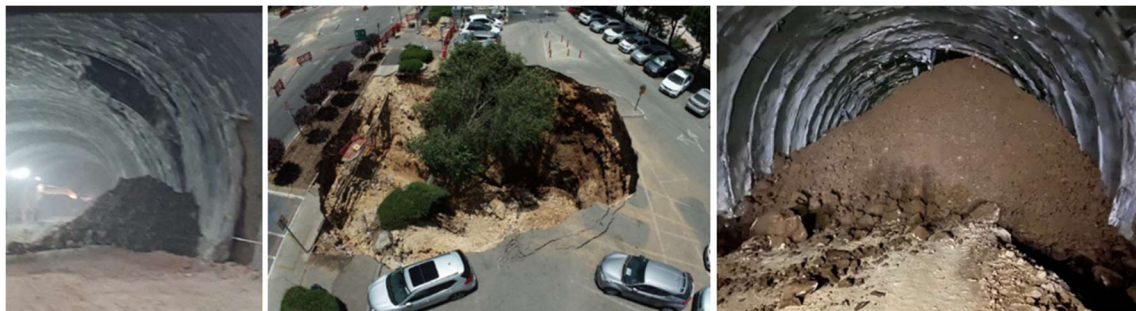
Figure 2. Onset of the TU4 collapse (left), formation of the surface crater (center – approximately 20 m diameter) and debris material inside the tunnel (property of the authors).

The first sign of instability suddenly occurred at about 2:00 p.m. on June 7, 2021 on TU4. After a few minutes, at about 2:15 p.m., the collapse had developed up to the surface, with a 50 m high chimney, forming a crater involving a hospital parking area and swallowing several parked cars. It should be noted that on the date of the collapse there had been no signs of possible criticality or instability and that the tunnels had already been fully excavated for more than 2 months, while the excavation of the section where the collapse occurred had been completed for more than 7 months for TU4 (October 2020) and 5 months for TU3 (December 2020). At the end, the collapse involved a primary lining length of  $12 \div 15$  m, made of fiber reinforced sprayed concrete, wire mesh and steel ribs (

Figure 2). During the excavation period, in the collapse area, no water flows were recorded, except for local water drips.
